Title: Surveillance Report on SAVY 4000 and Hagan Nuclear Material Storage Containers Update for Fiscal Year 2020

Surveillance Report on SAVY 4000 and Hagan Nuclear Material Storage Containers Update for Fiscal Year 2020

Executive Summary

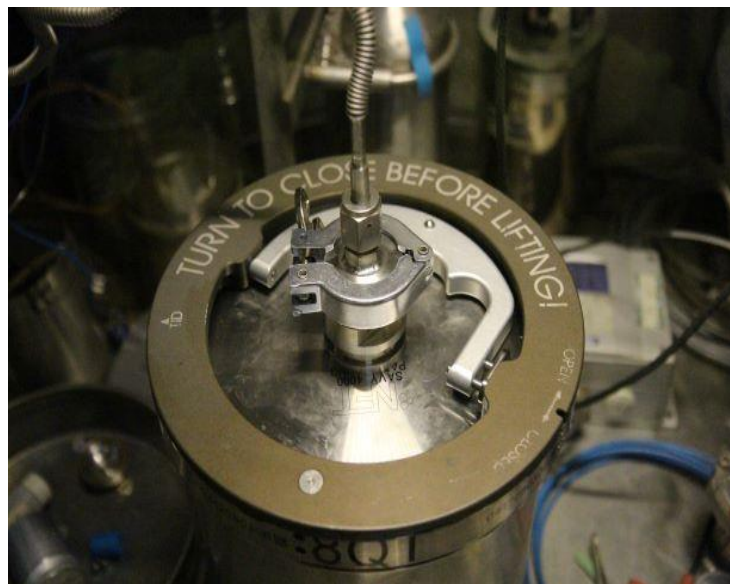
Figure 4-27 Visual inspection results of 20S9(203) during unpacking. Helium Leak testing verified in-glovebox capability.

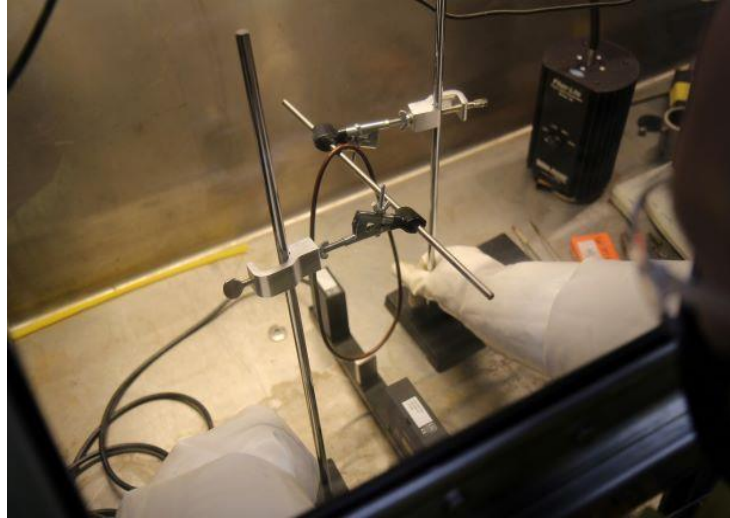
Figure 4-28 Visual inspection results of 20S9(203) during unpacking. Laser micrometer measurement of O-rings verified in-glovebox capability.

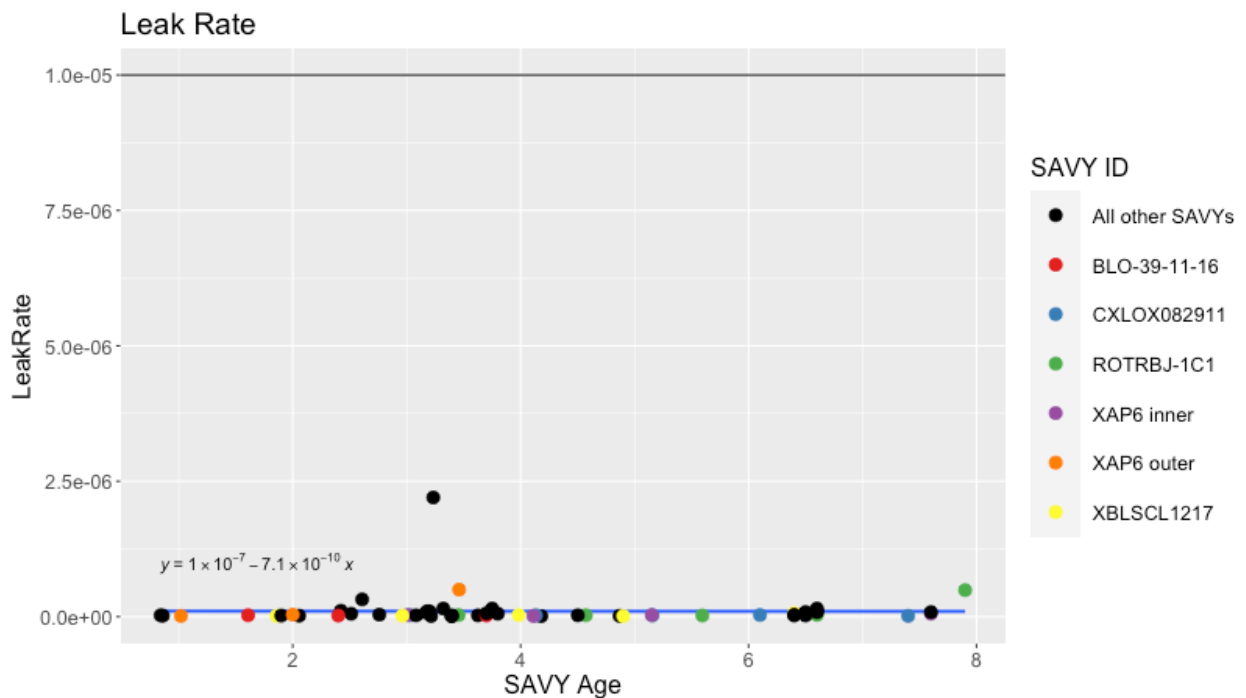
Figure 4-33 **Trend analysis of He leak rate versus SAVY age for containers from 2015-2020** shows He leak rate versus age. The containers denoted with colored circles are the five containers that have been examined at least twice in 2015 through 2020. The black circles are the remainder of the SAVY surveillance containers (38 containers). (One of the SAVY containers, item 20S9 (random ID 203) did not have an official helium leak rate measurement as it was in the glovebox, but it did pass a glovebox leak rate test.) The black horizontal line on the graph is the acceptance limit for He leak rate. To date, there is no trend with time for leak rate. There is one outlier, XBLSC1213 (the highest black point) that was discovered in 2018. This container was corroded and it required cleaning to pass the leak test, however it is well below the acceptance rate. This container will be re-examined again in a future surveillance. XAP6 outer container and ROTRBJ-1C1 were not re-examined in 2020, but will also be re-examined in a future surveillance.

Figure 4-33 Trend analysis of He leak rate versus SAVY age for containers from 2015-2020

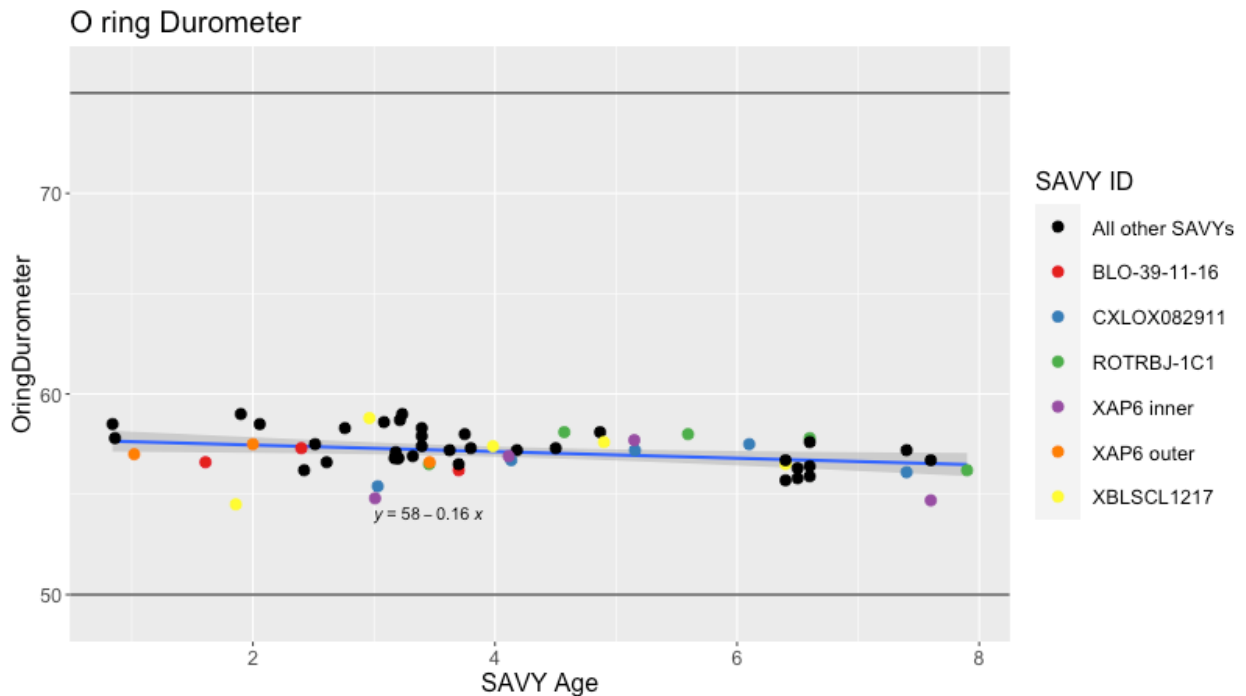
Figure 4-34 shows durometer measurements versus SAVY age. There is a slight downward trend, however there is considerable variability and the containers that have been measured multiple times (colored dots) do not show a trend. The black horizontal lines are the acceptance limits, the blue line is the trend line, and the gray shaded area is the 95% confidence bound for the trend line.

Figure 4-34 Durometer measurements versus SAVY age for containers from 2015-2020

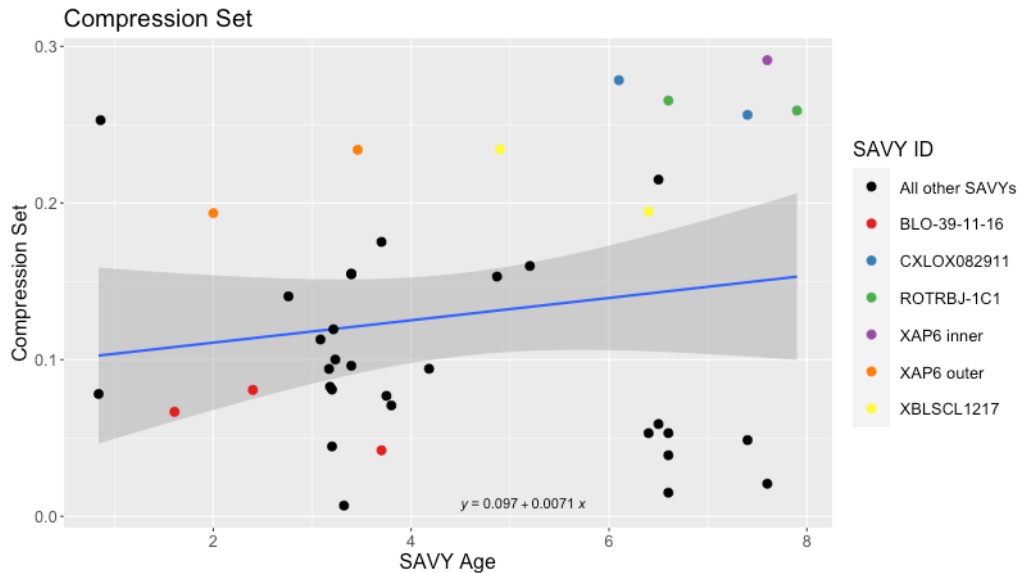
The surveillance compression set data were not collected in 2015 or 2016, there were three measurements in 2017. In 2018 three measurements were made but two of those were estimated based upon the average gland size for containers. In 2019 and 2020, compression set measurements were taken for all containers. The values ranged from 0.015 to 0.26. The maximum compression set value allowed is 0.65. All of the measurements are well below that value. Of the six containers with multiple measurements over time (multi-colored dots) only one has more than two measurements, BLO-39-11-16, which has three measurements. The compression set measurements indicate a small positive trend. However, looking at the items that have multiple

measurements there is not a positive increase except for XAP6 outer (orange dots). All other containers that have measurements over time are approximately the same value or slightly lower. Given the considerable variability in the measurements, more data are needed before a trend can be reliably assessed.

Figure 4-35 Compression set versus SAVY Age for SAVY containers in surveillance from 2015-2020.

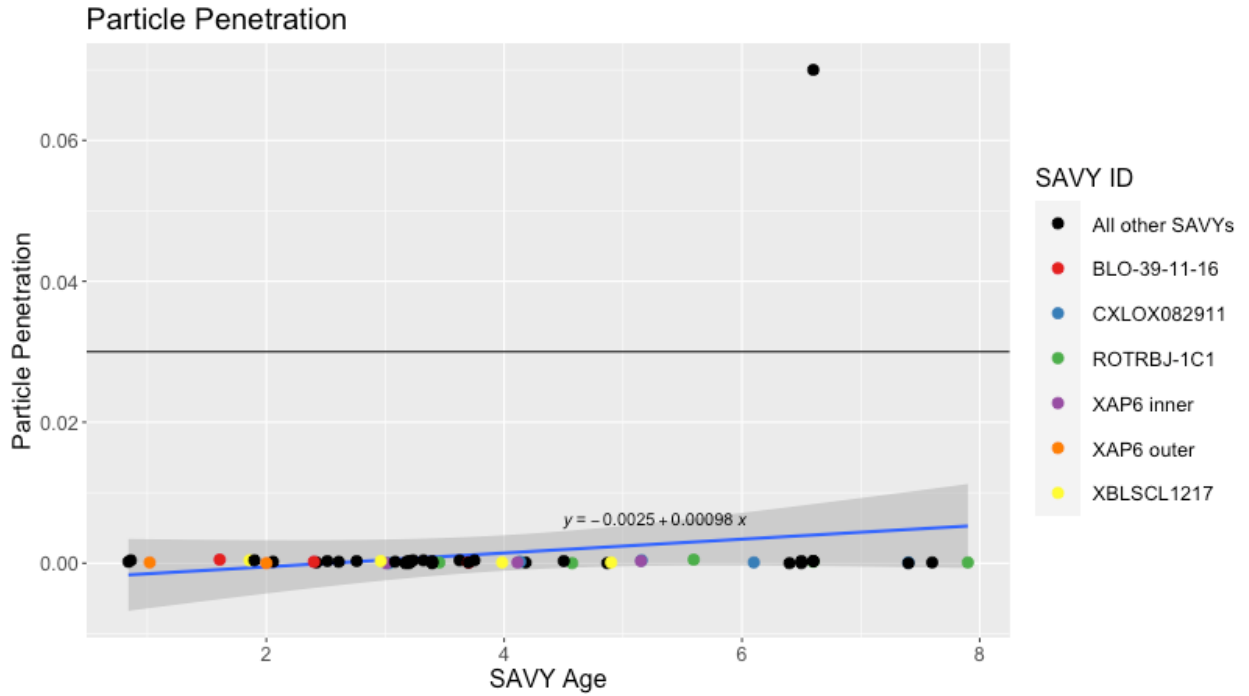
Figure 4-36 shows particle penetration versus SAVY age. This measurement depends on how long the data are collected and the collection time can vary between measurements. The variability in the collection time results in variability between measurements leading to scatter in the actual measurement values across the years. The gray shaded area is the 95% uncertainty band for the trend line. Although the trend appears positive, the variability of the data is such that the trend is not statistically significant. Additionally, there is one point (highest black point) that causes the positive trend. This container was from one of the random items. It was the first SAVY-4000 to fail the particle penetration test and was found to have some damage on the filter membrane as indicated in Section 4.2.1.8. Removing this point, Figure 4-37 and Figure 4-38 show that there is a slight downward trend where all the containers are well below the acceptance limit of 0.03.

Figure 4-36 Trend analysis of particle penetration versus SAVY age for SAVY containers in surveillance from 2015-2020.

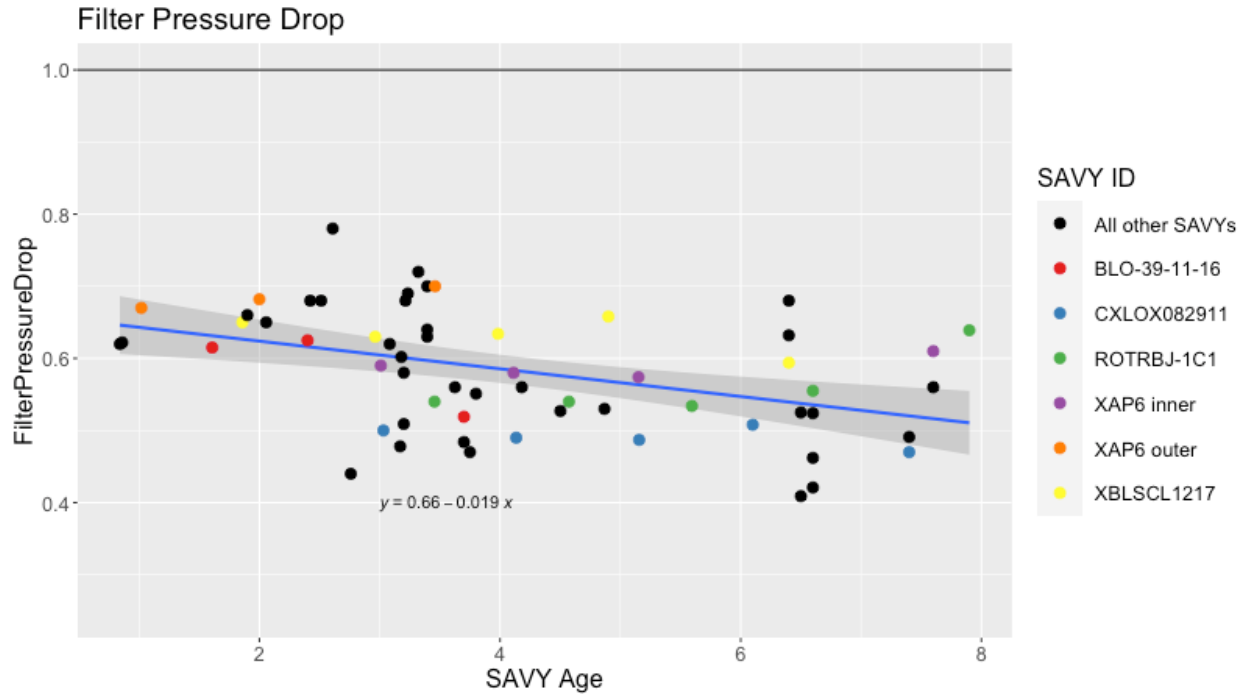
Figure 4-39 shows the plot of filter pressure drop versus SAVY age. There is a negative trend in the data, however, there is a lot of scatter and the five containers measured multiple times (colored circles) show no change with age. To date, all filters have passed acceptance testing and a negative trend would not be an issue as the acceptance criterion does not include a lower limit.

Figure 4-39 Filter pressure drop versus SAVY age for items in surveillance from 2015-2020.

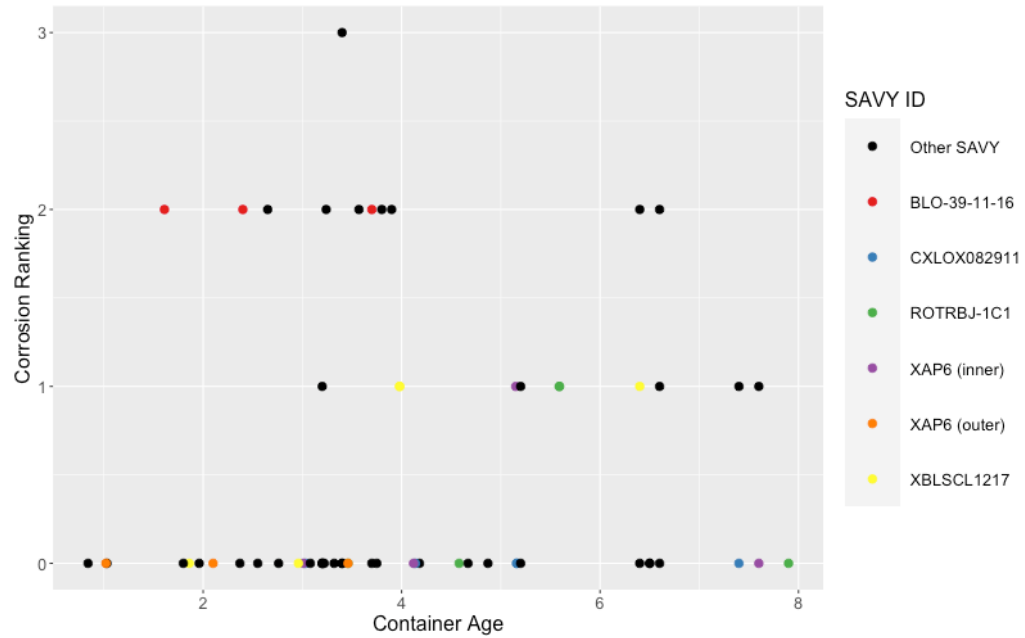
Both scatterplots and boxplots¹ are used to look at the impact of age, wattage and BDF on the corrosion levels, 0-“no corrosion”, 1-Isolated General Corrosion, 2- Light General Corrosion and 3- Heavy General Corrosion as described in Section 2.2.7. The scatterplot and boxplot of the corrosion ranking versus age (**Figure 4-40** and **Figure 4-41**) indicate that age alone does not have an impact on corrosion. Age varies across all the corrosion levels with the “no corrosion” category having the widest spread. Containers that were tracked over time, XBLSC1217 (yellow dots), XAP6 inner (purple dots) and ROTRBJ-1C1 (green dots) were not in the 2020 surveillance. These containers will be examined in a future surveillance.

Figure 4-40 Scatterplot of SAVY 4000 container corrosion ranking vs. age from 2015-2020.

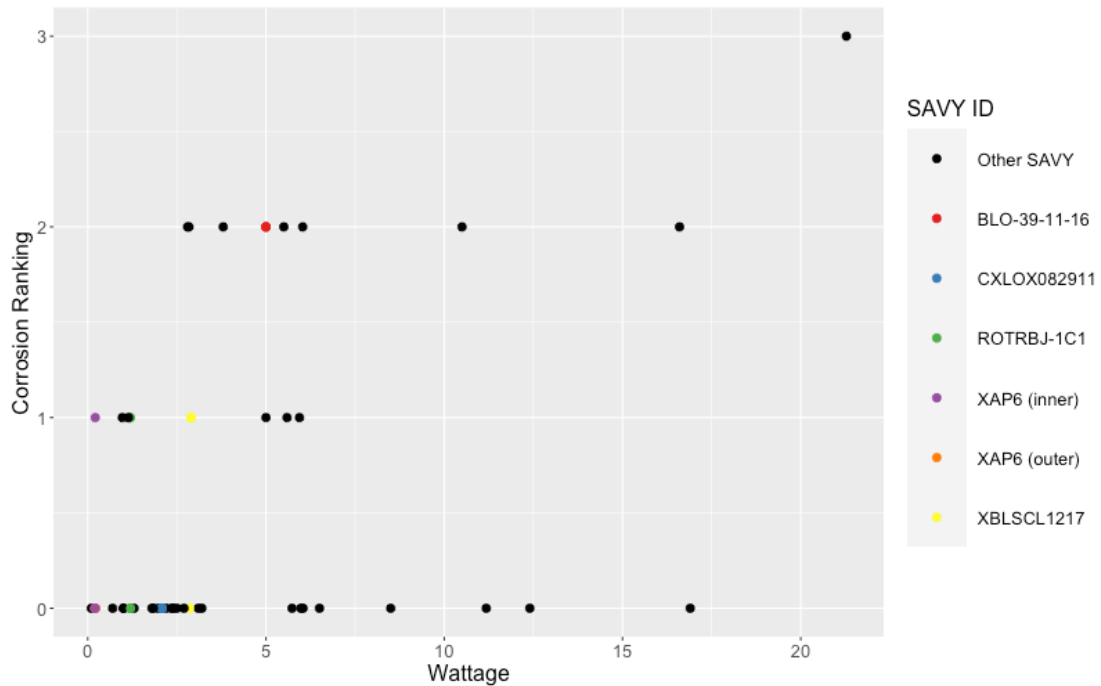
Figure 4-42 and Figure 4-43 show corrosion ranking versus wattage. Currently, there is only one observation that had a corrosion ranking value of 3 which was in 2016, item AAP02OX. However, no other SAVY containers in surveillance have seen that high of

corrosion since 2016. In the 2020 surveillance there was one container, the stringer item, that had a high wattage but no corrosion. This item had five metals in it each with an individual wattage around 3.4, totaling a wattage of 16.9. The items that have been in surveillance multiple times, BLO-39-11-16, XBLSC1217, and XAP6 inner changed categories in 2018 but not in 2019 and were not examined in 2020. The initial BLO-39-11-16 corrosion was level 1 (covered in plot) and the initial XBLSC1217 corrosion was level 0. They will be evaluated in a future surveillance.

Figure 4-42 Scatterplot of SAVY 4000 container corrosion ranking vs. Wattage from 2015-2020.

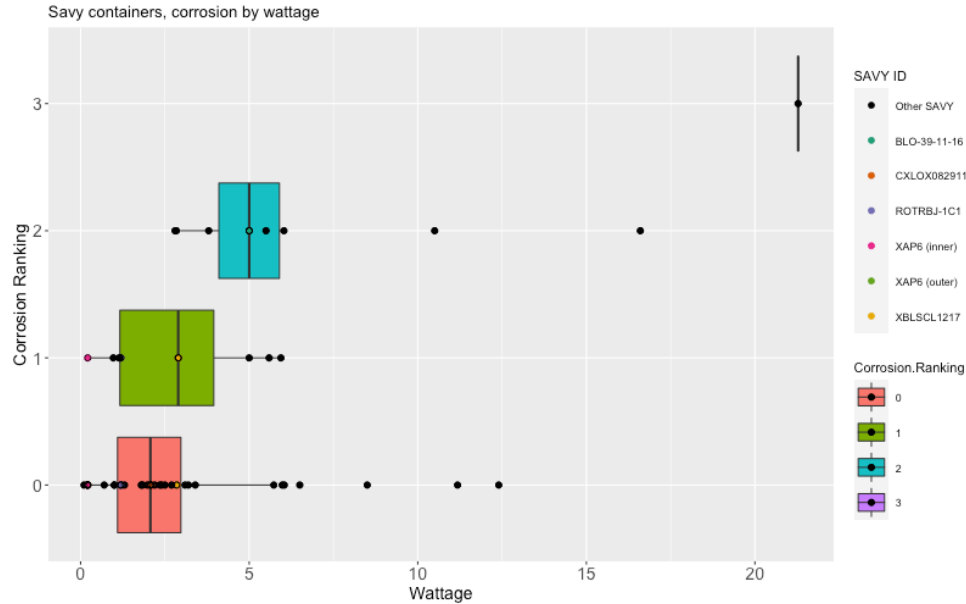
The medians of wattage between the different corrosion categories shown in Figure 4-43 indicates a slight increasing median wattage for increasing corrosion rankings. There is a significant difference between the no corrosion category and category 2.

Figure 4-43 Boxplot of Corrosion rankings vs. wattage in years for the 2015-2020 SAVY containers.

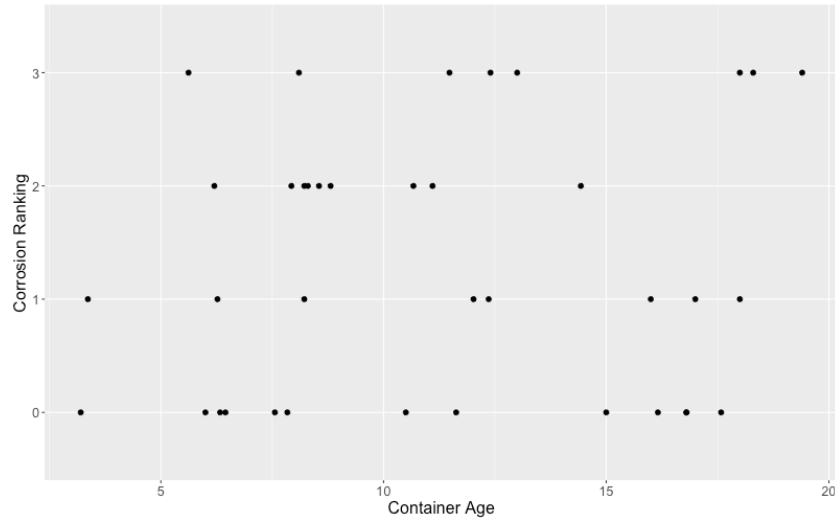
Figure 4-46 and Figure 4-47 show scatterplots of the corrosion ranking versus age and boxplots of ages per corrosion ranking, respectively. Similar to the SAVY, there is a lot of variability in age, especially for the non-corroded containers. These plots indicate that age alone does not predict corrosion.

Figure 4-46 Hagan container age vs. corrosion ranking for data from 2015-2020.

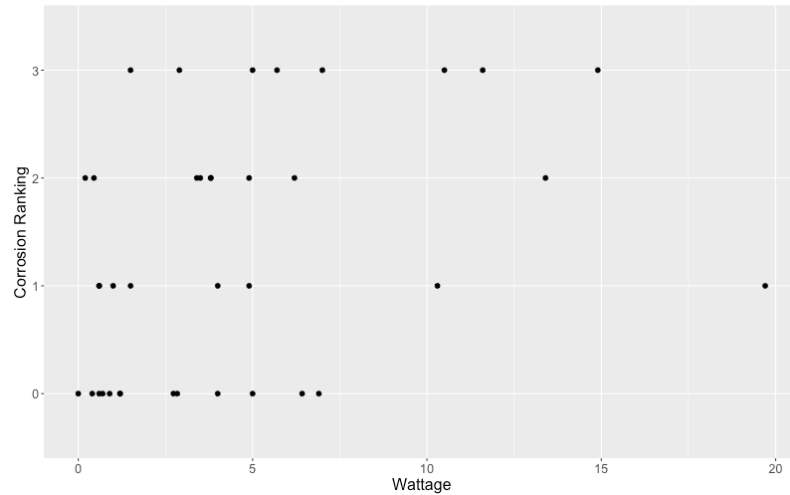
Figure 4-48 and Figure 4-49 show plots of the corrosion ranking versus wattage and boxplots of wattage per corrosion ranking, respectively. The scatterplot in Figure 4-48 shows that all containers have some corrosion for wattages greater than 10 watts. The boxplot shows that there is a general increasing trend of wattage medians as corrosion levels increase. However, there is not a significant difference between the medians. There is considerable variability in wattage for those containers having corrosion.

Figure 4-48 Scatterplot of Hagan container wattage vs. corrosion ranking for data from 2015-2020.

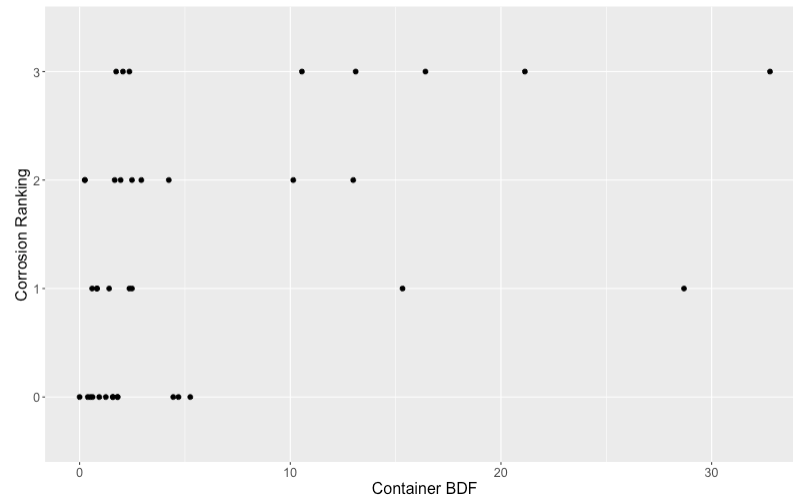
The plot of corrosion ranking versus BDF, Figure 4-50, shows that all nine containers with BDF greater than 10 have some corrosion. The boxplots of corrosion ranking versus BDF (Figure 4-51) show a slight increasing trend of BDF medians, i.e., the greater the BDF median the higher the corrosion ranking. Again, similar to wattage the general trend of higher medians is not significant.
